U.S. Department
of Transportation
**National Highway
Traffic Safety
Administration**

DOT HS 811 862

November 2013

Motorcoach Side Glazing Retention Research

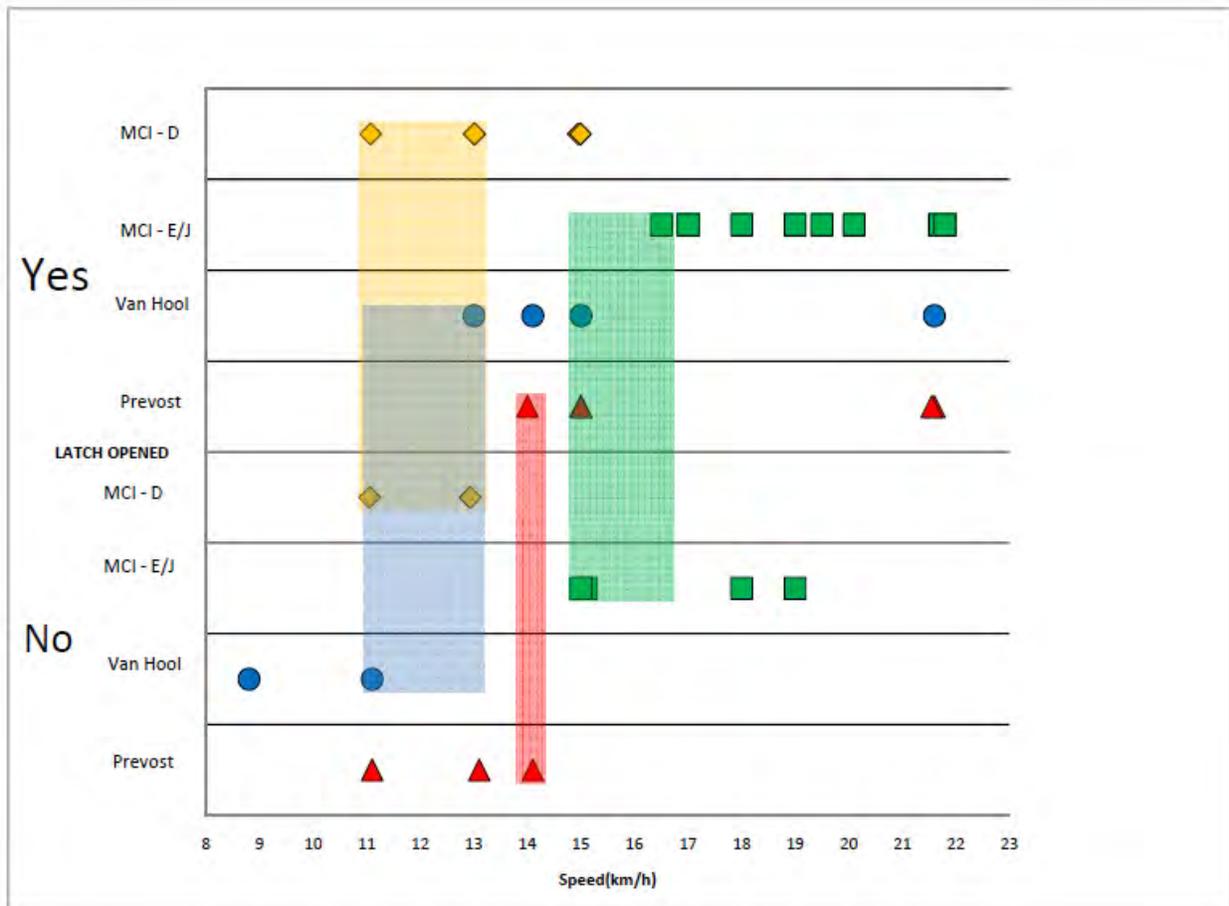
Figure 5.13 Primary Latch Unlatching Threshold Velocities Using 22.7 kg Mass

Figure 5.1 shows the results of each motorcoach type grouped according to whether the window remained latched or unlatched for tests conducted near the primary latch. Shaded bands are overlaid to show the transition velocity where unlatching occurs. That transition speed for the MCI E/J-series was in the 15 - 16 km/h range. Unlatching occurred by one of two slightly different events. In some of the tests, the primary latch's detent lever, under impact loading, transferred a force great enough to deform the striker plate and unseat the striker post from the plate. The post rotated in the direction of impact allowing the lever to slide over the post as seen in Figure 5.14. In other tests, the latch bar rotated upward during the impact event, which opened the primary latch's detent lever prior to the lever sliding over the post.

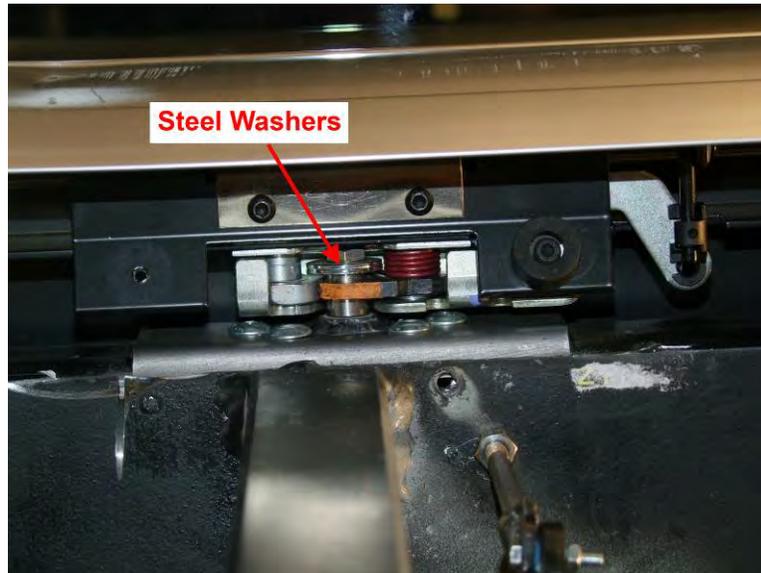
Figure 5.21 Modification A1 With Window Latched

Steel washers were added to the top of the post in each modification to see if this could prevent the detent lever from sliding over the post (referred to as Modification A1 and Modification B1). Figure 5.21 shows Modification A1 with the window in the latched position. The detent lever was painted orange for clarity purposes. Impact tests were conducted at the near-latch position at 21.6 km/h.

The results of all modification testing are shown in Table 5.2. Both Modification A1 (MCI GLZ FRM 19) and Modification B1 (MCI GLZ FRM 20) prevented the window from unlatching. A final modification involved adding steel washers to the post on a production latch plate assembly, which was also tested at 21.6 km/h. Deformation was seen in the primary latch plate, but the washers prevented the detent lever from sliding over the post and the window remained latched.

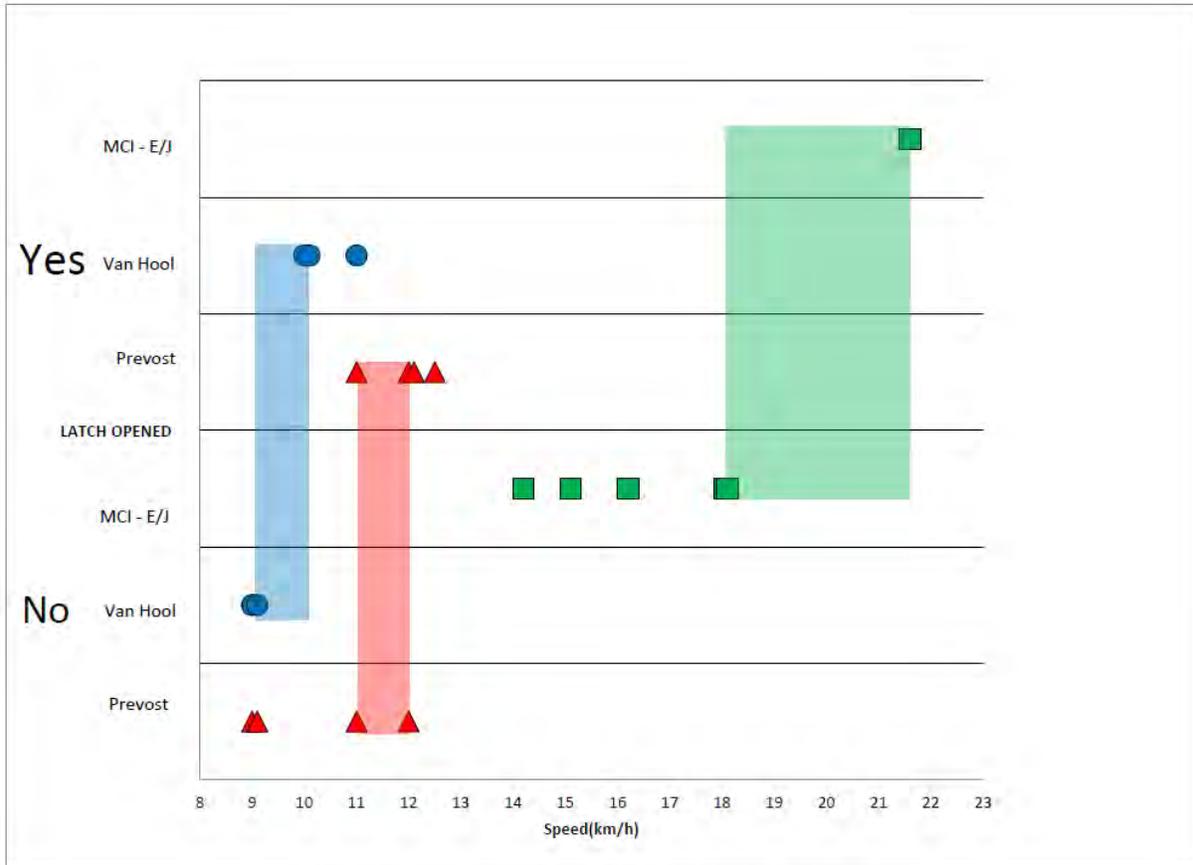
Figure 6.3 Unlatching Threshold Velocities for Production Latches Using the 26 Kg Impactor

Figure 6.3 shows the results of each motorcoach type grouped according to whether the window remained latched or unlatched for tests conducted near the primary latch. Shaded bands are used to show the transition velocity where unlatching occurs. As expected, the transition velocities were lower for both the Van Hool and Prevost windows: 9 – 10 km/h and 11 - 12 km/h respectively. An increase in transition velocity was unexpectedly measured in the MCI E/J-series: 18 - 21.6 km/h.

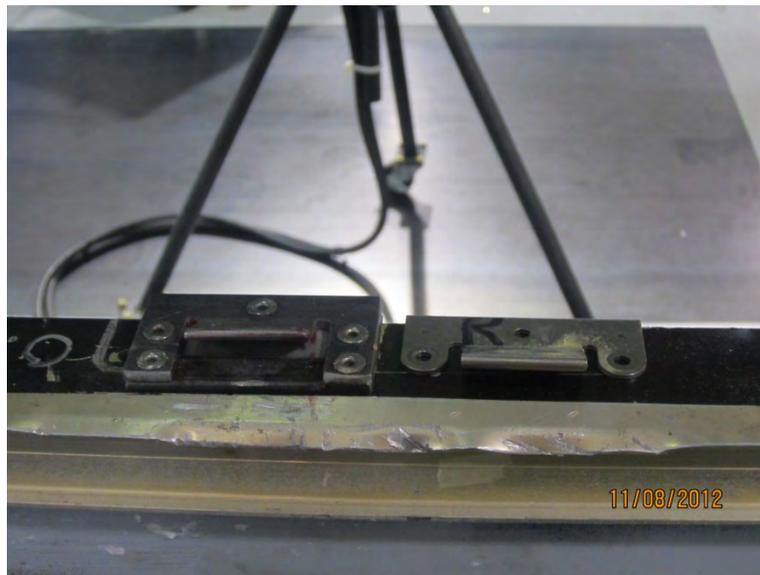
Figure 8.1 Van Hool Modified Spring Clip (left) Versus Production Spring Clip

Failure in the Van Hool latching system occurred when the spring clip mounted on the bus body bent backwards due to impact forces allowing the window to open (see Figure 5.18). The production clip is made from stainless steel with a thickness of 0.058 inch. Modified spring clips were fabricated out of cold rolled steel with a thickness measuring 0.130 inch. The modification is shown in Figure 8.1 on the left. Two additional rivets were used to attach the modified spring clips to the bus body. Both production spring clips were replaced with this modification. A series of impact tests were conducted at the Martec study conditions and are summarized in Table 8.2. Subsequent modifications were made to the latching system based on test observations and are described below.

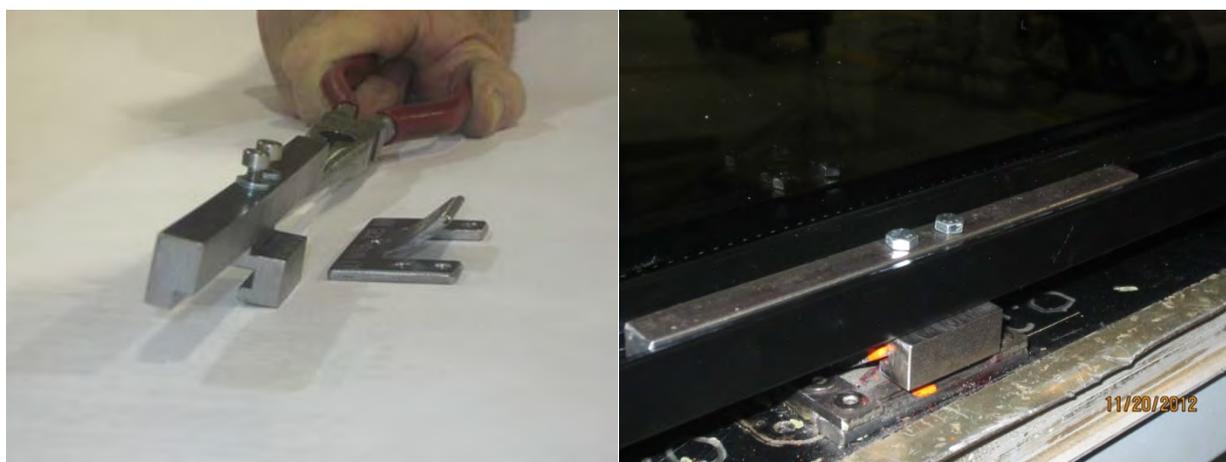
Figure 8.2 Van Hool Latch Countermeasure System

An impact (VH GLZ FRM 14) was conducted 25 mm above the primary countermeasure latch at 21.6 km/h. The window unlatched at both locations and swung open. The glass did not break. The failure occurred when the sliding mechanism located under the window pulled partially out from the track, rotated, and slid over the spring clips. There was no visible damage to the modified spring clips. An angled aluminum bar was fastened to the window track at both latch locations to provide stiffness, and the impact conditions were repeated (VH GLZ FRM15). Similar results were seen in the latch failure, and the window opened while the glass remained intact. Modifications were subsequently made to the slider mechanism. The brass production mechanisms were replaced with ones fabricated out of steel containing a longer lip to catch more of the spring clip. A steel reinforcing bar measuring 6 inches in length was inserted into the window frame channel and attached to the slider mechanism with stainless steel screws. Figure 8.2 shows the modifications made to both latching mechanisms. Increasing the spring clip stiffness prevented the window from closing on itself when released from an open state as designed in the production units. The emergency handle could still be used to slide the mechanisms for latching purposes but unlatching required a force greater than 40 lbs.

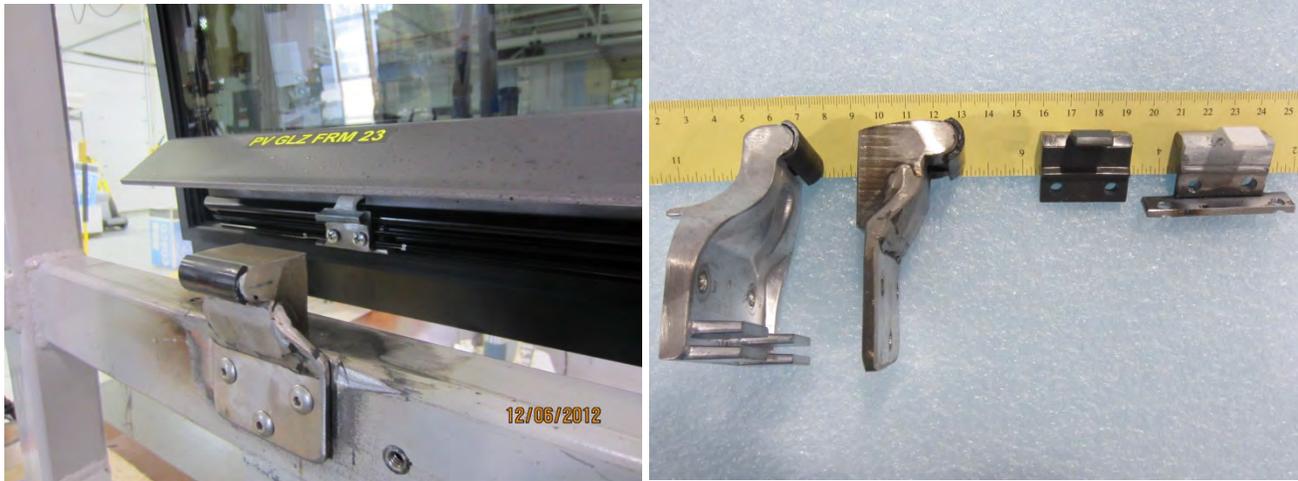
Figure 8.4 Prevost Striker Post and Locator Tab Countermeasures

Failure in the Prevest latching system occurred by three different modes: shearing of the aluminum striker post which allowed the latch bar to swing open, shearing of the plastic locator tabs which help to secure the latch bar to the window frame channel, and shearing of the composite latch bar. Striker post and locator tab countermeasures were fabricated out of steel at VRTC to provide increased strength (VRTC did not have the in-house capability to fabricate a suitable latch bar countermeasure). The modifications are shown in Figure 8.4.

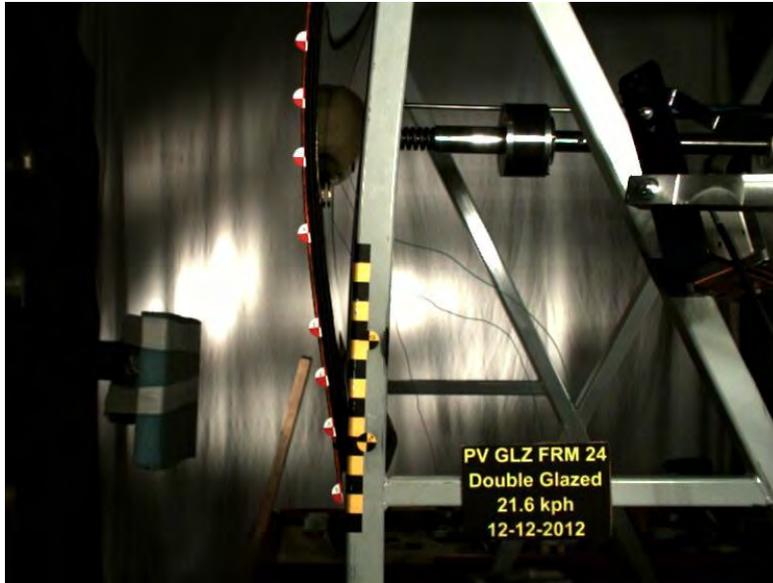
Figure 8.6 Prevest Maximum Dynamic Deflection in Center of DLO Impact

In an impact test conducted at the center of the daylight opening (PV GLS FRM 24), the latch countermeasures remained latched. The window bowed outward and the impactor face displacement measured 69 mm, but there was no damage to the tempered glass panes. Figure 8.6 shows the maximum dynamic deflection captured from high speed video.

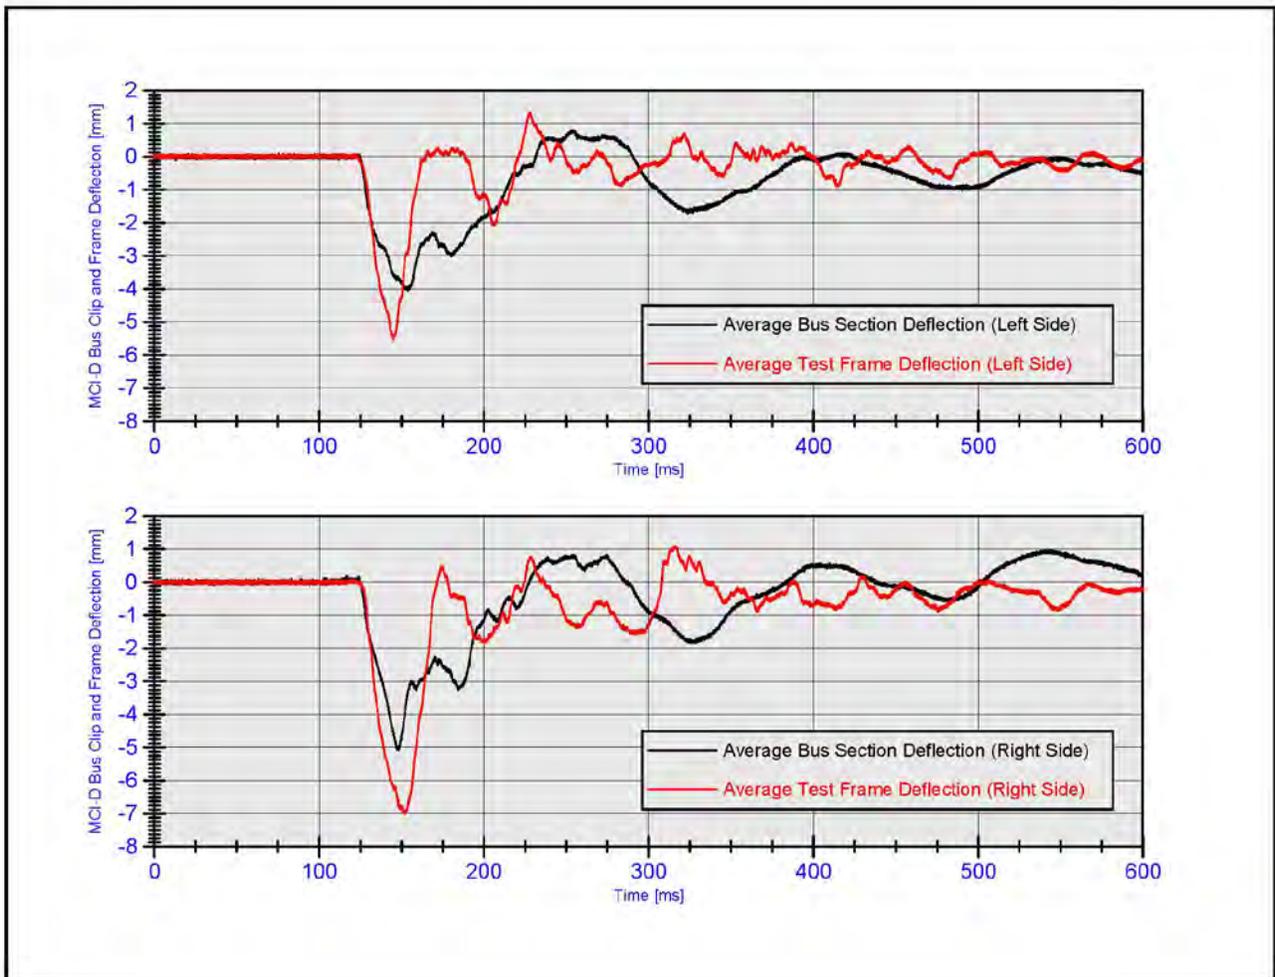
Figure 11.2 MCI D-Series Motorcoach Section Versus Frame Average Deflection Plots

The results are shown in Table 11.1. The windows unlatched and swung open in every test. In previous testing (in the bus body section, Table 3.1), the polycarbonate window remained latched when it was tested under these impact conditions (see Table 11.1), and the window frame was slightly distorted in this test series due to multiple impacts which most likely contributed to its opening. The deflection measurements were averaged and compared for the left and right sides and are shown in Figure 11.2. The results show that while the frame flexes more initially, it is more rigid and has a shorter period of vibration than the bus section. The more massive bus section (with its smaller peak deflection) was placed on, but not physically anchored to the floor, while the test frame section was “anchored” to the floor by heavy concrete blocks.
